UNITED STATES
DEPARTMENT OF THE INTERIOR
BUREAU OF MINES

Memorandum

Subject: Coal Bump, Olga mines, Olga Coal Company, Coalwood,
McDowell County, West Virginia, April 26, 1965

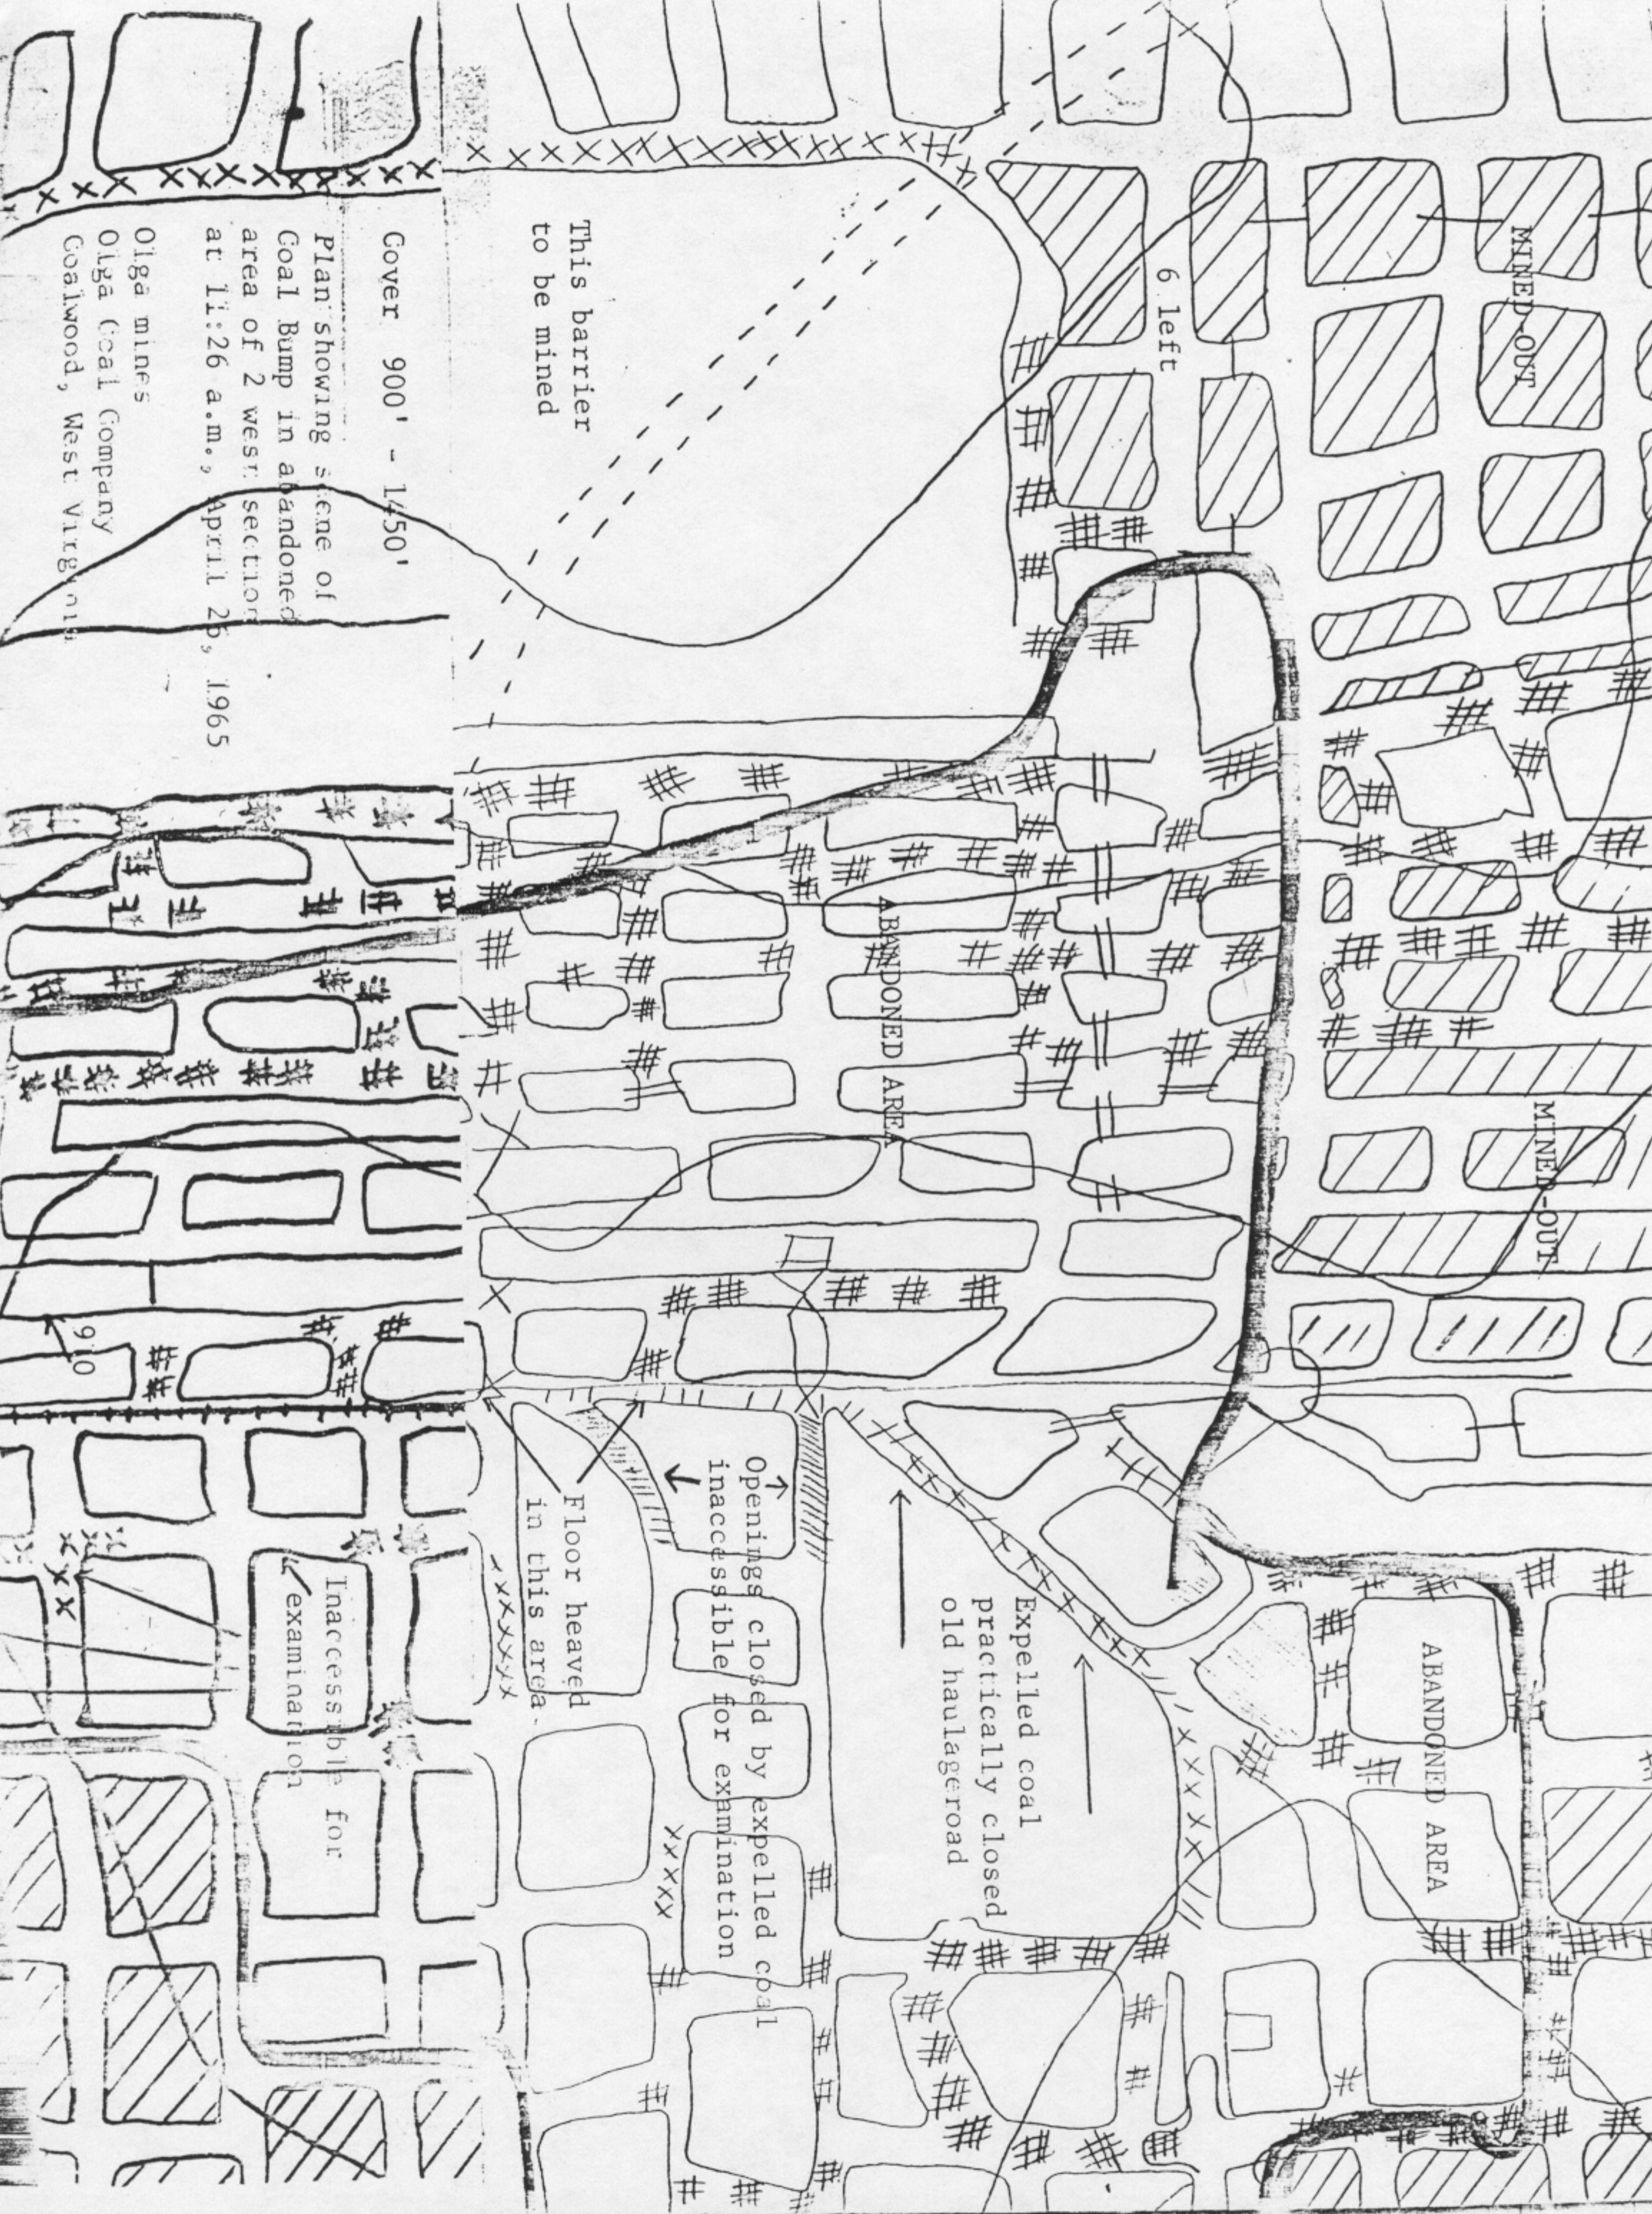
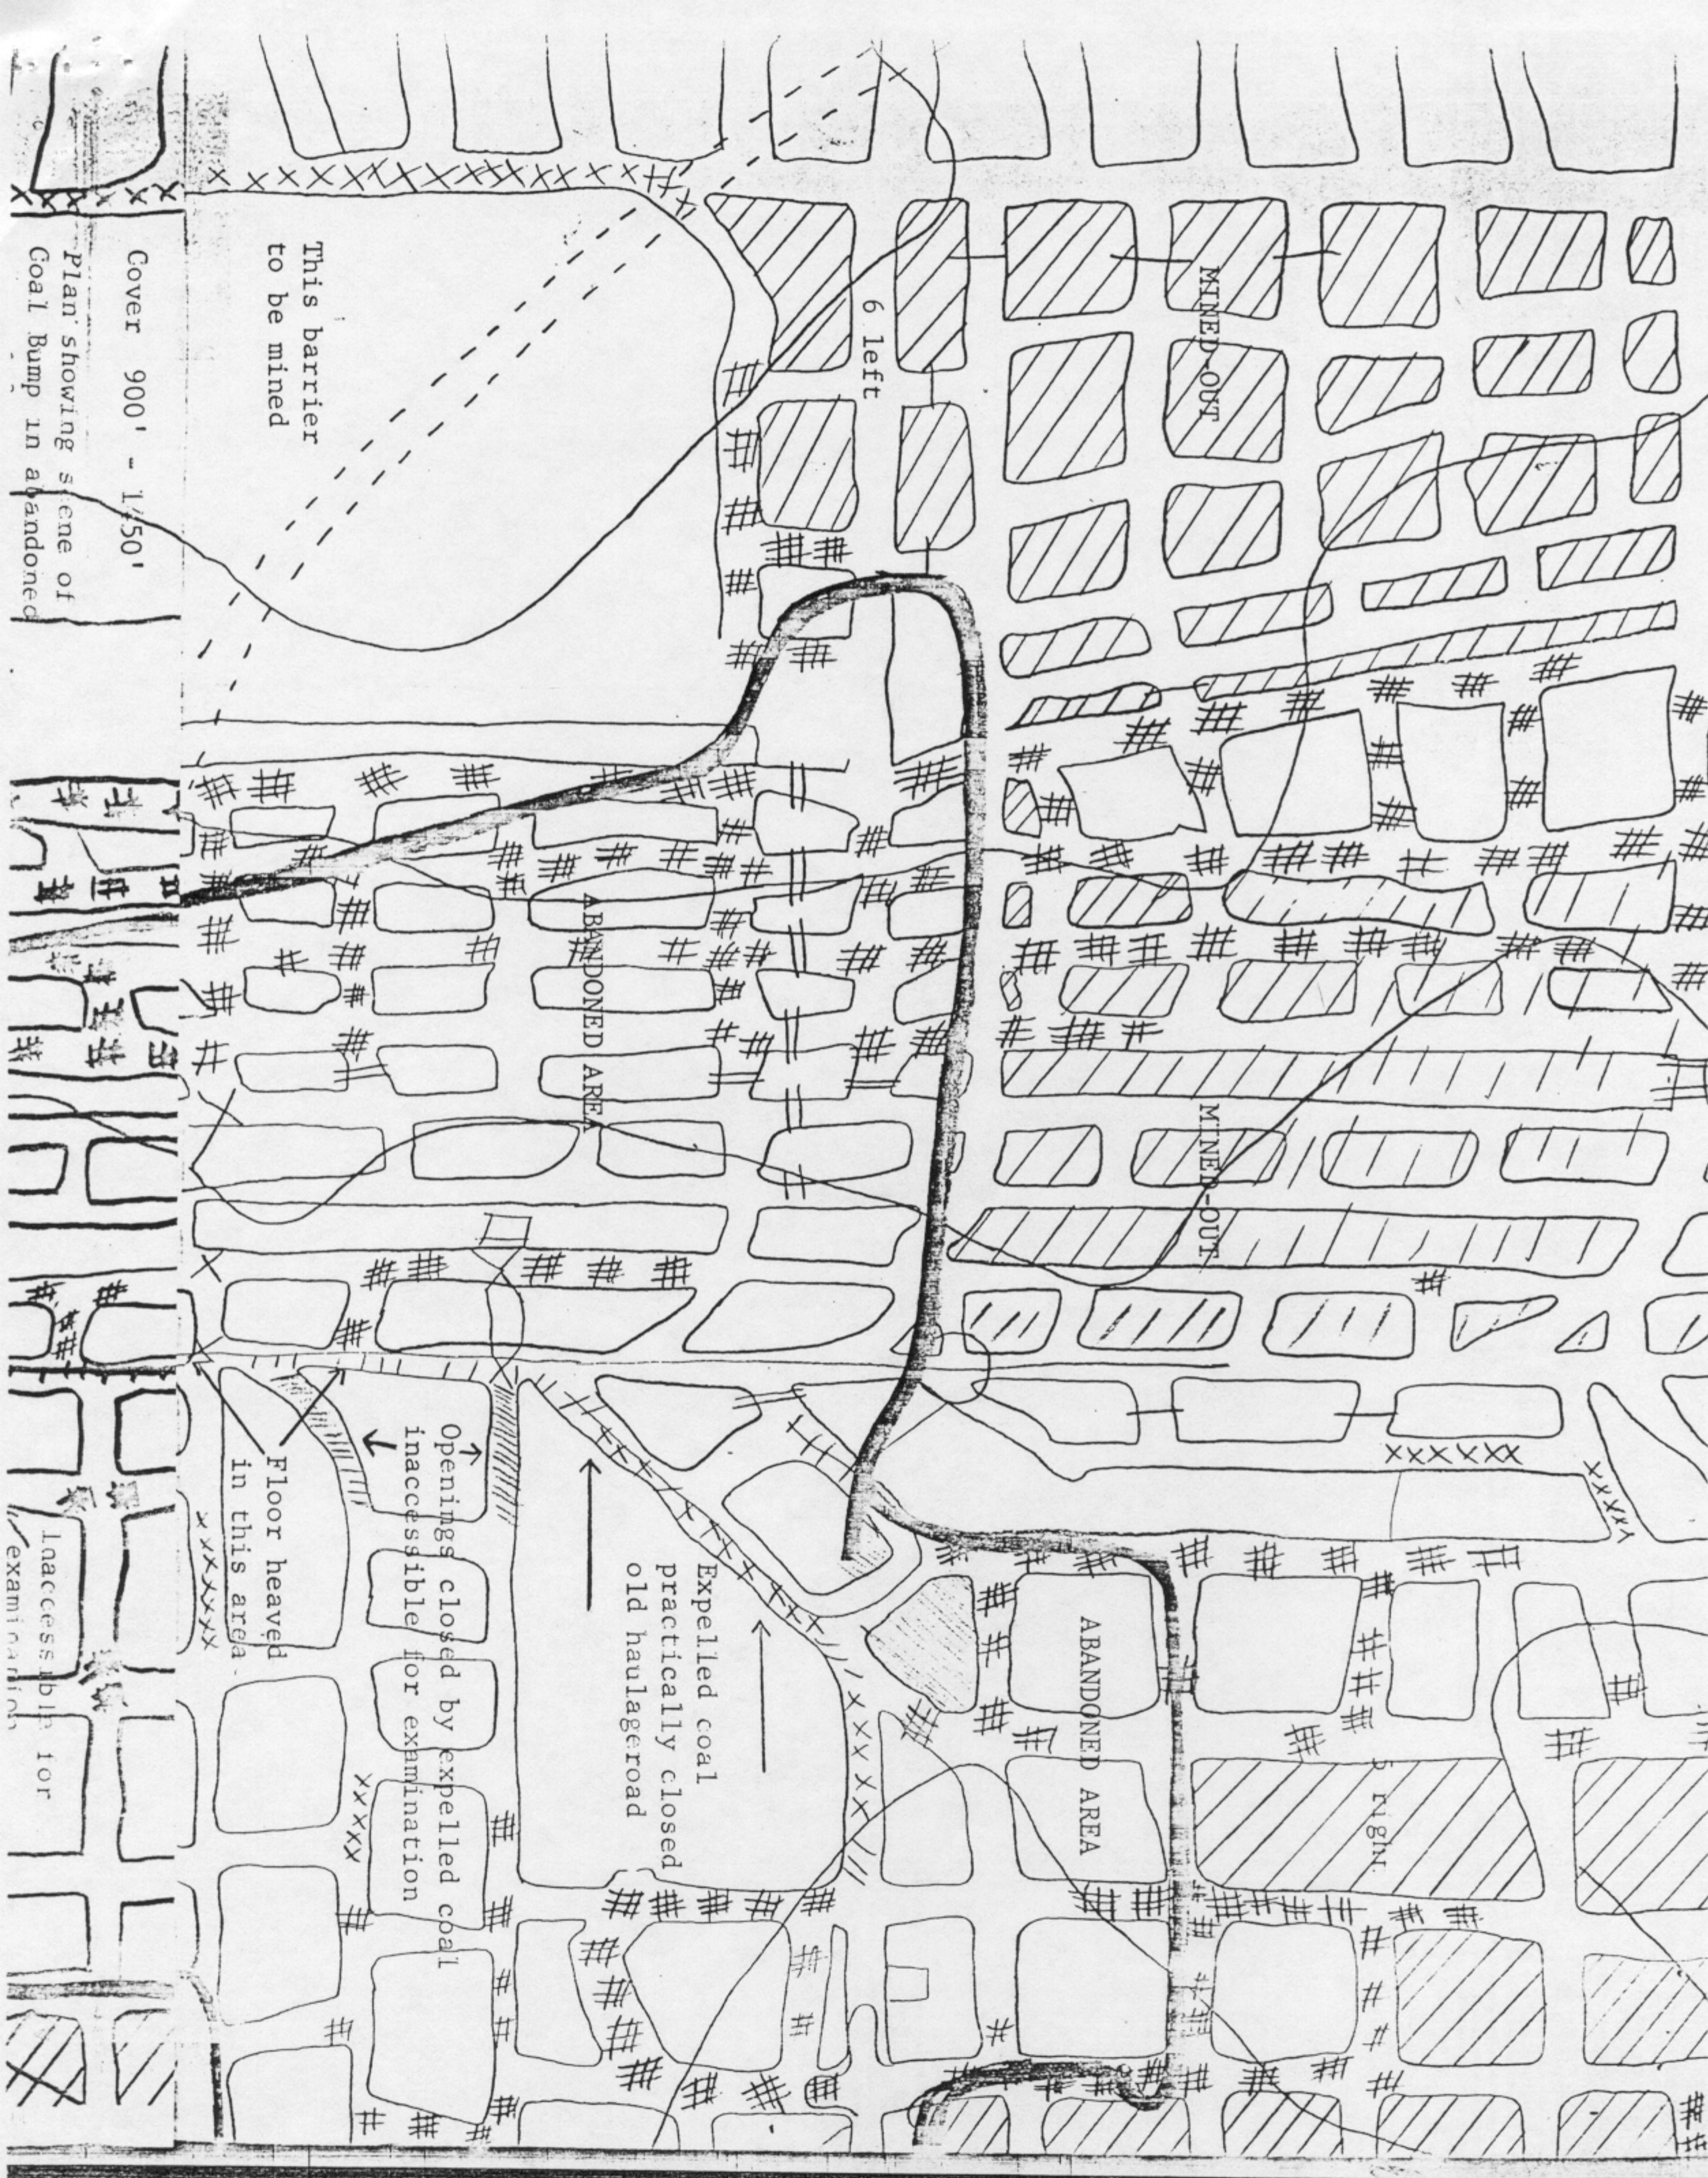
Olga mines
Olga Coal Company
GoaLwood, West Virginia

The attached mine print shows the specific area involved, the focus of the bump, locations where coal was expelled violently from pillars, areas where the floor was affected, and the extent of extraction when mining was discontinued in the area on March 23, 1965. The mine print also shows where mining was resumed in 2 west on March 24, 1965, and the extent of current development in barrier pillars between 4 and 6 lefts, 2 west, at the time of the bump on April 26.

This abrupt release of energy by the April 26 bump resulted in coal being expelled violently and in sufficient quantities from the ribs of the trapezoidal pillar and the immediate adjacent pillars to completely or partially fill the surrounding openings at the locations indicated in the attached print. Small amounts of roof were shaken down at 3 locations along the abandoned haulage roads. The floor was affected and upheaved along the abandoned section of the 2 west haulageway as shown on the print. The cave line where pillar mining terminated apparently remained unchanged since the area was abandoned on April 23.

From the attached print, it will be noted that the size of the pillars in the abandoned area of 2 west are comparatively large and therefore are capable of large load-bearing capacities, especially the large trapezoidal pillar at 5 right. The presence of these pillars and their relative locations evolve into the area becoming a zone of disturbance where stresses likely will be released intermittently by resultant movements in the future. From the attached map, you will note that current mining is in the barrier pillar opposite the abandoned area (enclosed by heavy line on mine map)
